# THE USUAL SUSPECTS

## Irregular Trailer Tire Conditions

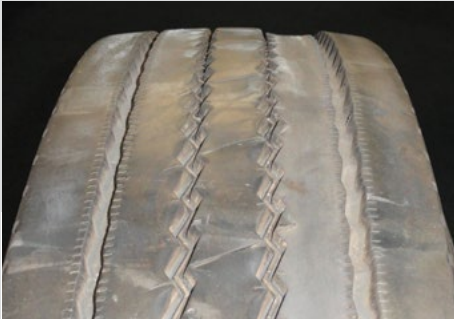
**Depression Wear**  
(Intermediate)

Appearance	One or more interior ribs (not center) worn below adjacent ribs around the tire's circumference.
Probable Cause	Worn suspension components, mismatched dual diameter or inflation pressures, under-inflation, improper bearing adjustment. Aggravated by high speed/light loads.
Corrective Action	Diagnose mechanical condition and correct.
Tire Disposition	Continue to run until pull point, then retread.

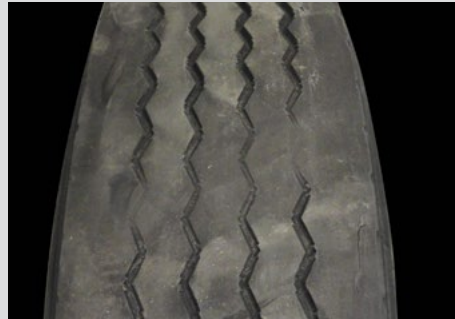
**Diagonal Wear**

Appearance	Localized flat spots worn diagonally across the tread, often repeating around the tire.
Probable Cause	Improper bearing adjustment, misalignment, mismatched dual tire diameter and/or inflation pressure. May start as brake skid. Aggravated by high speed/light loads.
Corrective Action	Analyze cause and correct.
Tire Disposition	Reverse direction of rotation. If excessive, submit for retreading.

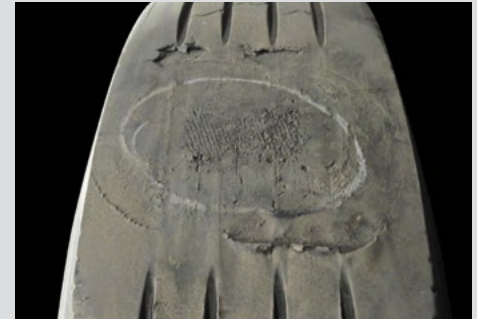
**Brake Skid Damage**

Appearance	Localized spot of excessive wear across tread face showing abrasion marks. Damage may extend into casing.
Probable Cause	New brakes (not worn in), unbalanced brake system, frozen brake lines, driver abuse.
Corrective Action	Check brake system.
Tire Disposition	May be repaired or retreaded if casing is undamaged; otherwise, scrap.

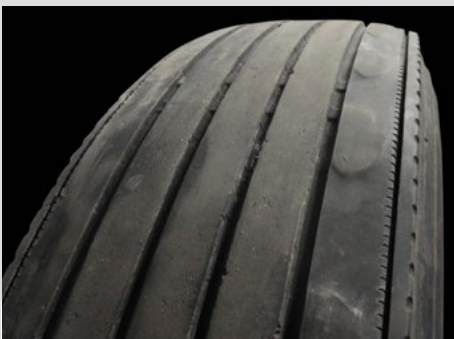
**Depression Wear**  
(Shoulder)

Appearance	Localized areas of wear in shoulder, generally less than 12" in length.
Probable Cause	Improper inflation pressure or tire mismounted on wheel. Can also be caused by some other type of wheel end imbalance.
Corrective Action	Review tire and wheel end maintenance practices.
Tire Disposition	Continue to run until pull point, then retread.

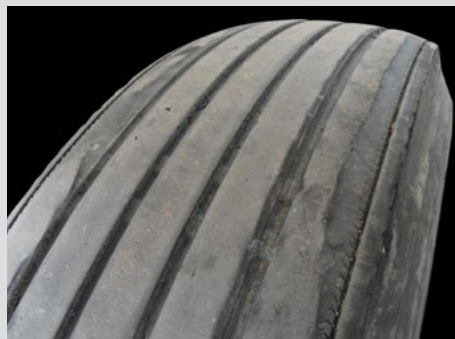
**Shoulder Step Wear**

Appearance	Tire worn on edge of one shoulder, greater than 12" in circumference.
Probable Cause	Excessive camber, misaligned or damaged axle, improper bearing adjustment.
Corrective Action	Diagnose misalignment and/or mechanical condition and correct.
Tire Disposition	Reverse direction of rotation. If excessive, submit for retreading.

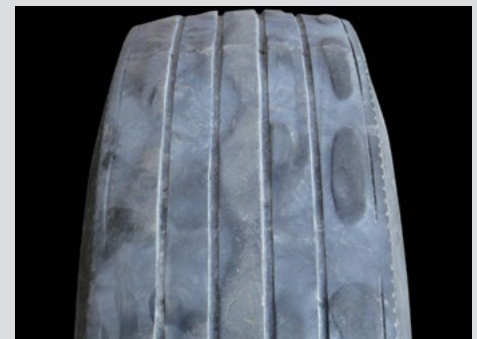
**Cupping / Scallop Wear**

Appearance	Random areas of fast wear around the tire. Erratic in some instances.
Probable Cause	Mismatched inflation pressure or tire diameters in a dual assembly. Aggravated by high speeds/light loads, poorly maintained suspension components.
Corrective Action	Check for worn components, inflation pressures and matching tread depths.
Tire Disposition	Continue to run until pull point, then retread.
